Overpressurization of Natural Gas Distribution System,
Explosions, and Fires in
Merrimack Valley, Massachusetts
September 13, 2018

NTSB/PAR-19/02
PB2019-101365

Pipeline Accident Report

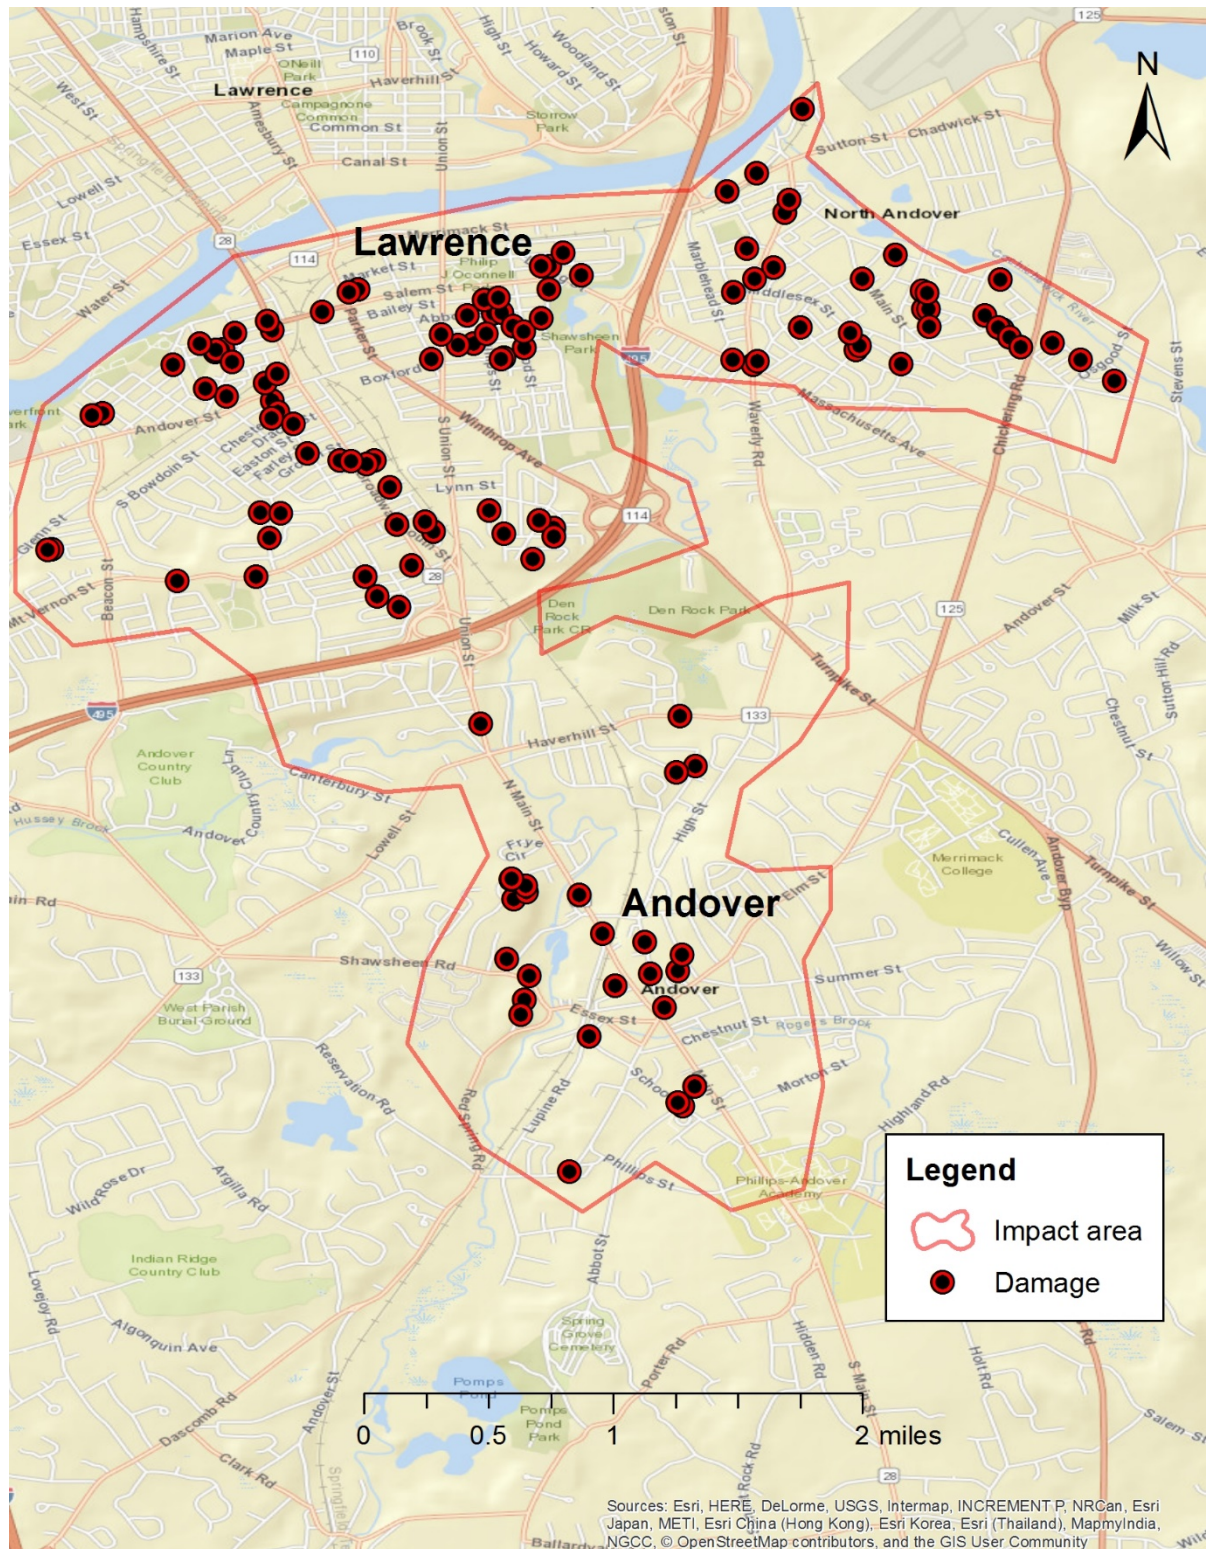
Figure 1. Map of the damaged structures in the area impacted by the overpressurization.

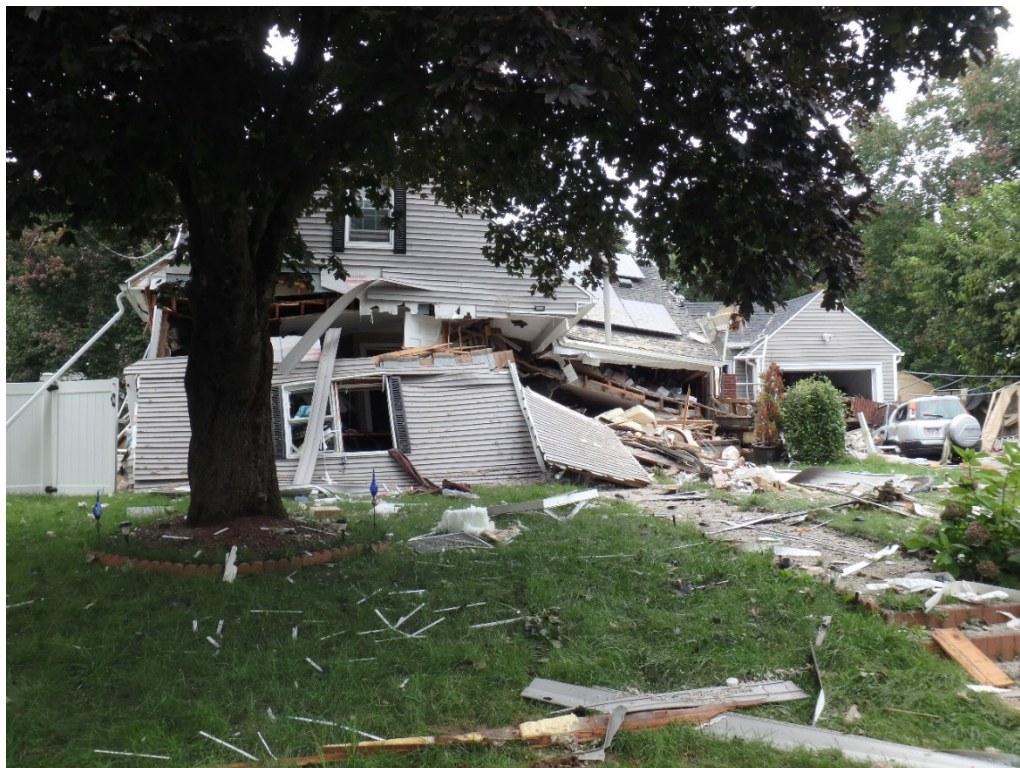
An 18-year-old male was killed when a home exploded, and the chimney fell onto the vehicle where he was sitting. (See figure 2.) Another person in the vehicle at the time of the

Figure 2. Remnants of house where the fatality and two severe injuries occurred.

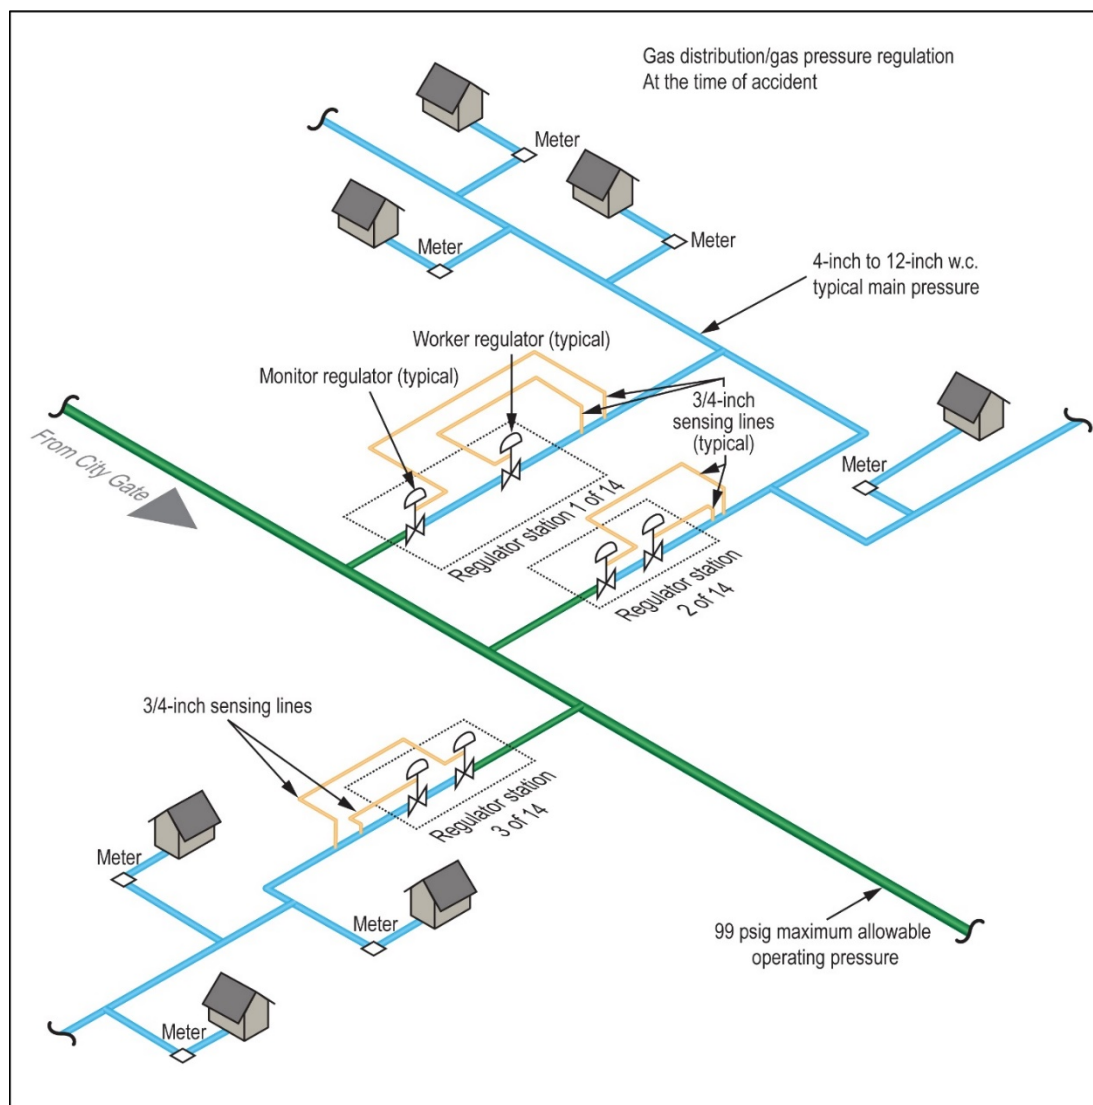
Since the regulator stations are the primary means of pressure control in the low-pressure systems, an overpressure condition in a natural gas distribution system could affect all customers served by the system. This is an inherent weakness of a low-pressure natural gas distribution system.

Figure 3. Typical configuration of the Merrimack Valley low-pressure natural gas distribution system.

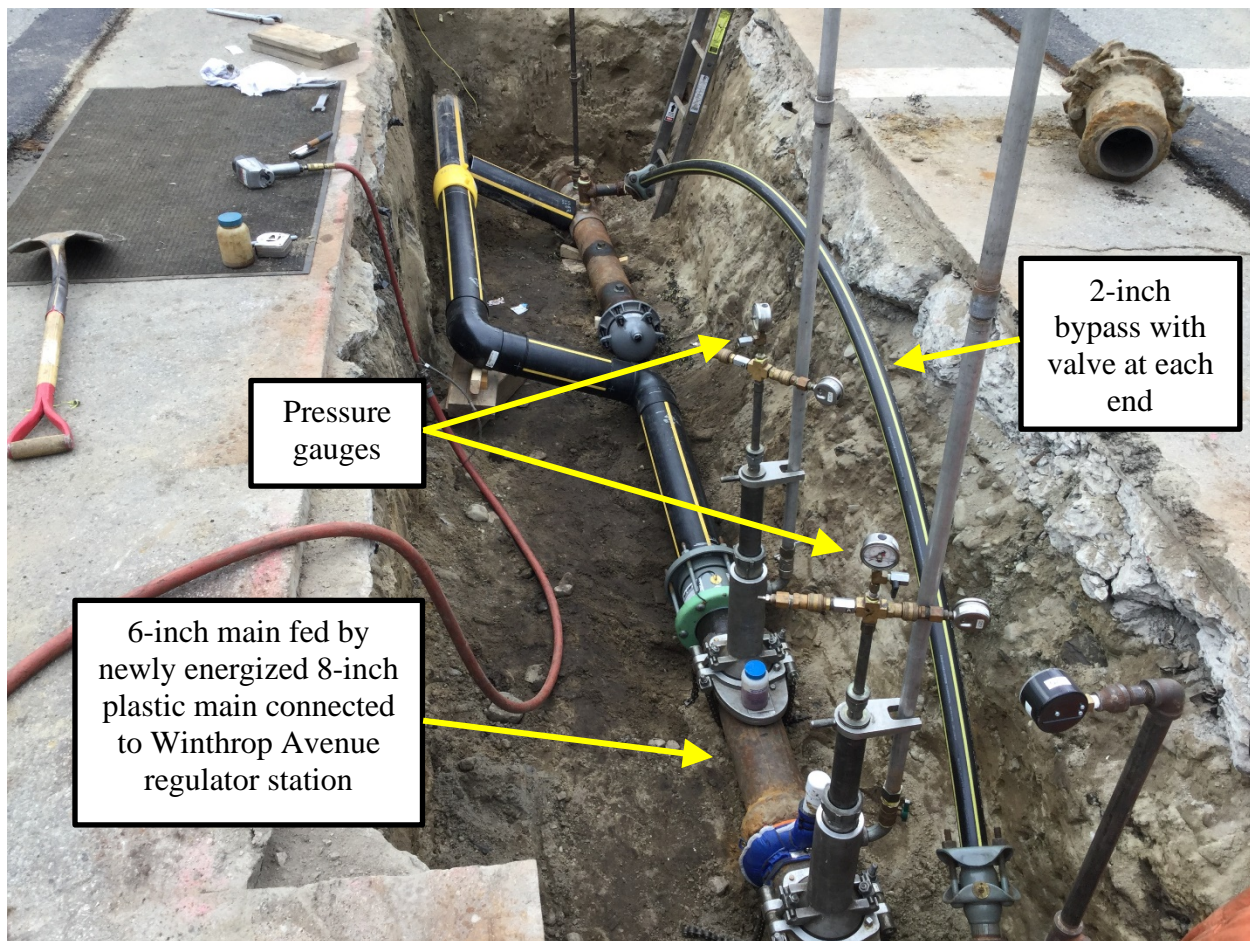
valves on a 2-inch plastic bypass pipe between the cast iron and polyethylene mains.⁸ The crew then cut the bypass pipe to abandon the cast iron main. (See figure 5.) In postaccident interviews, crewmembers said that within minutes of closing the valves and cutting the bypass, they observed the pressure gauge on the polyethylene main exceed the expected readings.⁹ Furthermore, a fitting on the polyethylene natural gas main blew off into the hand of one of the workers. The crewmembers said that they responded quickly to plug the blowing natural gas, and they heard emergency vehicles in the neighborhood and observed smoke plumes in multiple directions within minutes.

Figure 5. Salem Street tie-in for the South Union Street project (looking west). Photograph courtesy of Feeney Brothers.

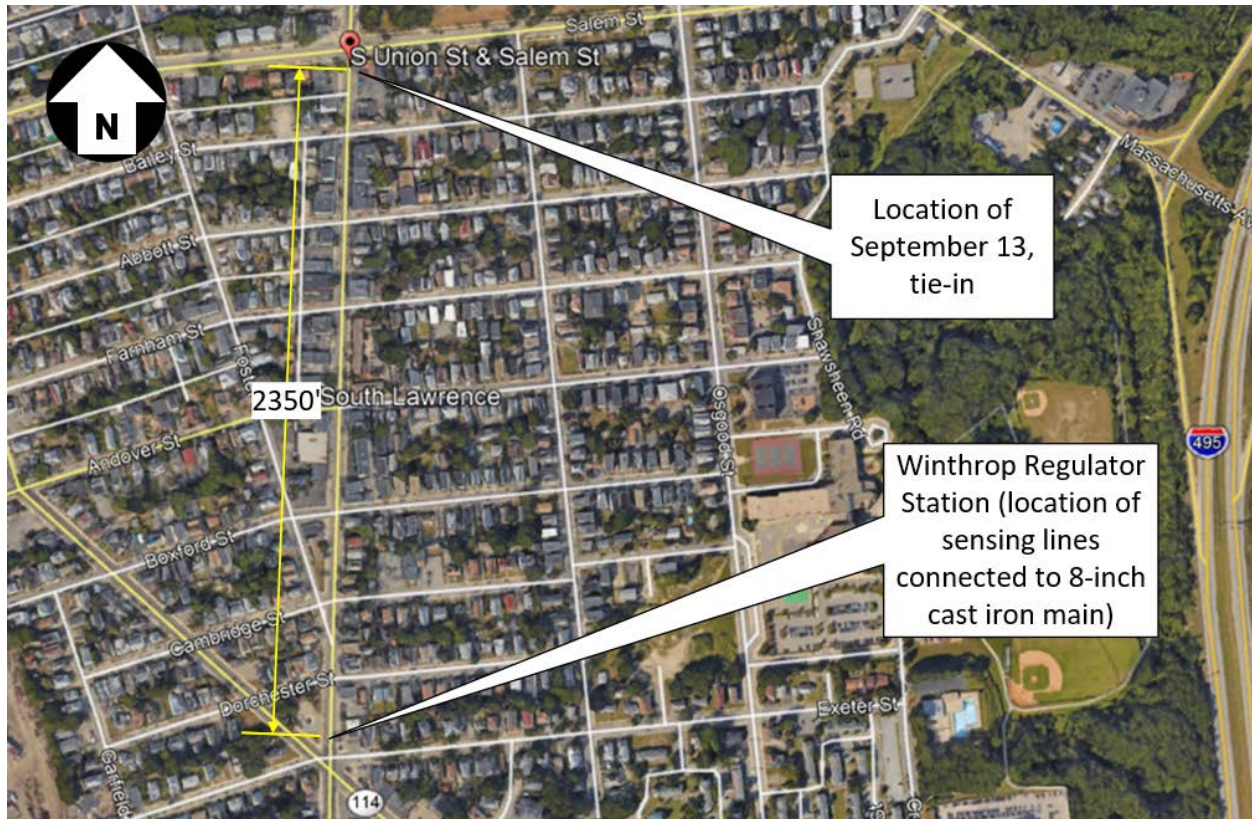
At the Winthrop Avenue regulator station, about 0.5 mile south of the work area, the abandoned cast iron main was still connected to the regulator sensing lines providing input to the two pressure regulators used to control the system pressure.¹⁰ (See figure 6.) Once the contractor

crew isolated the cast iron main, the natural gas pressure began to drop in the cast iron main and in the regulator sensing lines. As the pressure dropped, the pressure regulators responded by opening further, increasing pressure in the natural gas distribution system. Since the Winthrop Avenue regulators no longer sensed system pressure, they fully opened, allowing high-pressure natural gas to be released into the low-pressure natural gas distribution system.

Figure 6. Location of September 13, 2018, tie-in and the Winthrop Avenue regulator station.

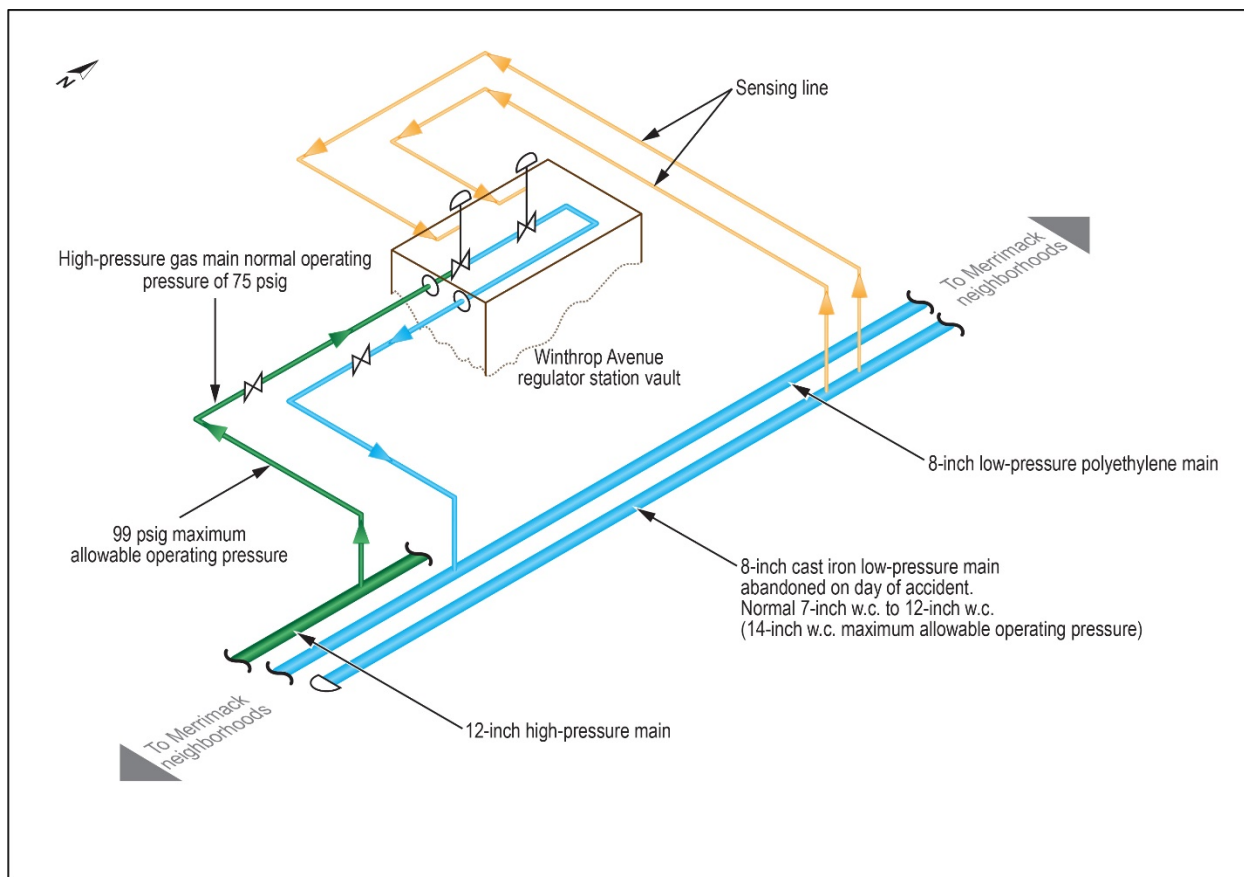
The first stage of the project involved the installation of the polyethylene main, which was completed in late 2016. The regulator sensing lines at the Winthrop Avenue regulator station remained attached to the cast iron main, where they controlled natural gas flow through the

Winthrop Avenue regulator station into both the cast iron and polyethylene mains, which were connected in the low-pressure natural gas distribution system. (See figure 8.)

The city restrictions, due to paving in the area, delayed the South Union Street project for more than a year. Prior to the delay, CMA connected the polyethylene pipe to the distribution system, which allowed it to be monitored for pressure changes. The second stage of the project began in 2018 and involved installing the tie-ins to the polyethylene main and abandonment of the cast iron main. On the day of the accident, the sensing lines were still connected to the cast iron main and were functionally disconnected from the distribution system when the cast iron main was abandoned.

Figure 8. The Winthrop Avenue regulator station.
