Overpressurization of Natural Gas Distribution System,
Explosions, and Fires in
Merrimack Valley, Massachusetts
September 13, 2018

NTSB/PAR-19/02
PB2019-101365

Pipeline Accident Report

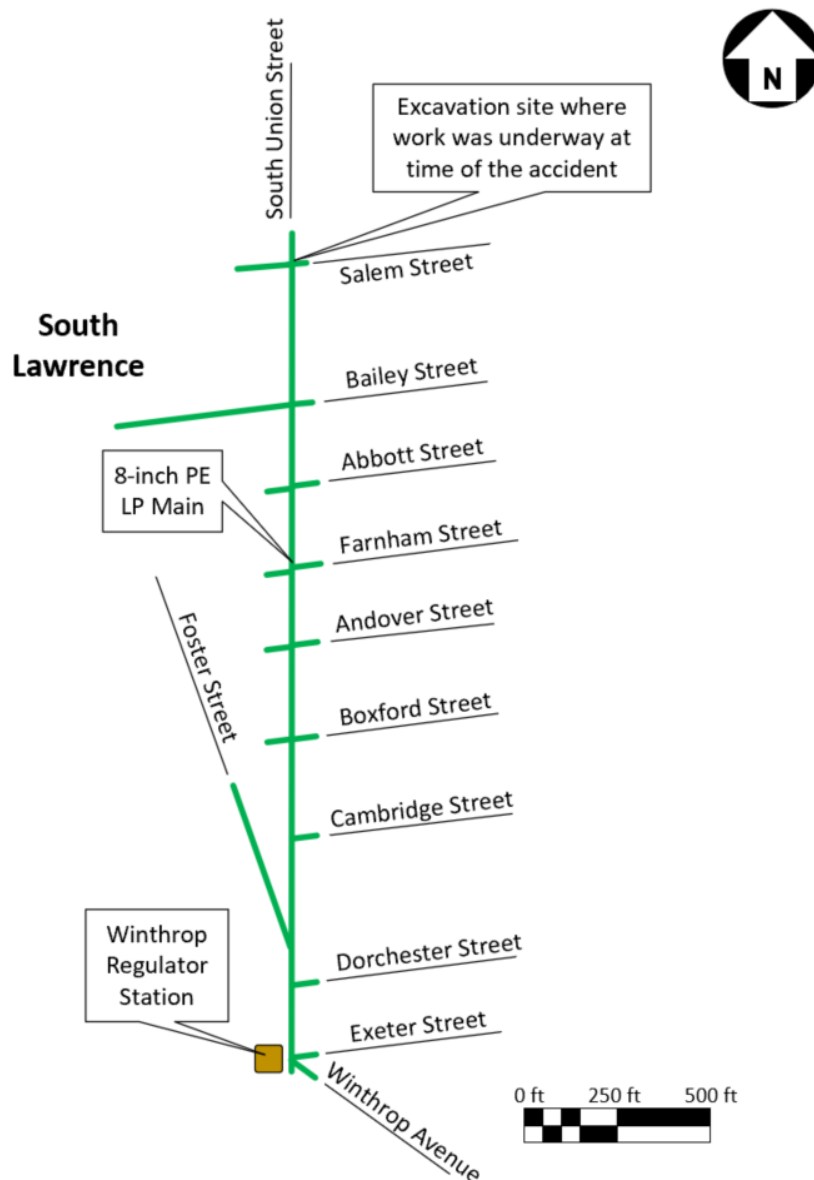
Figure 7 shows the area of the replacement of the natural gas main in South Lawrence along South Union Street with the cross-street tie-ins. The work on the day of the accident was at the north end of the project at Salem Street. The Winthrop Avenue regulator station is at the south end of the project.

Figure 7. Areas along South Union Street with tie-ins impacted by the project.
